# Maxillary anterior implant restoration with orthodontic treatment for esthetics: A case report of two cases

Youla Kim, Wonsup Lee, Su-Young Lee

*Department of Prosthodontics, Seoul St. Mary's Hospital, College of Medicine, The Catholic University of Korea, Seoul, Korea*

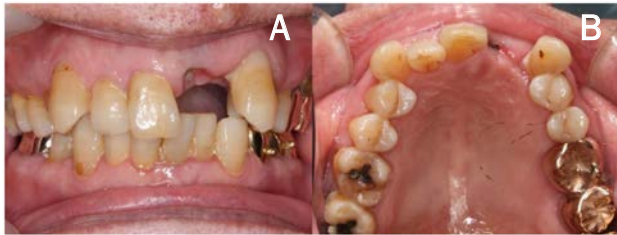
**Figure 1.** Pretreatment intraoral photographs. (A) Frontal view. (B) Occlusal view of maxilla.

Intraoral and extraoral examination reveal anterior crowding, especially biased #11 to the left based on the facial midline, labial transposition of #23, and the narrower width of edentulous area (#21, 22) than the width of opposite teeth (#11, 12) (Figure 1). In order to resolve the crowding of anterior maxillary dentition and restore esthetic implant prostheses, alignment of anterior maxilla and implant treatment were planned in collaboration with the orthodontist. Because the missing space was narrow, we decided to restore only one implant (#21) closing the space of #22. Orthodontic treatment was performed for 6 months (Figure 2). After 3months of starting the orthodontic treatment, the position and the angle of the implants were carefully determined with CBCT radiographic examination (Figure 3).

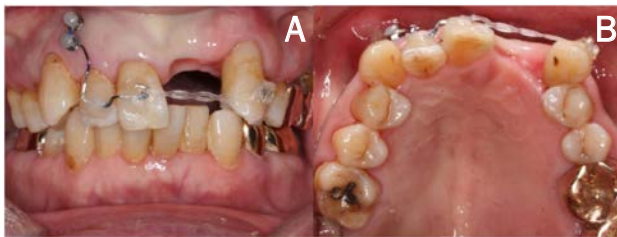
**Figure 2.** Intraoral photograph taken under orthodontic treatment on anterior maxilla. (A) Frontal view. (B) Occlusal view of maxilla.

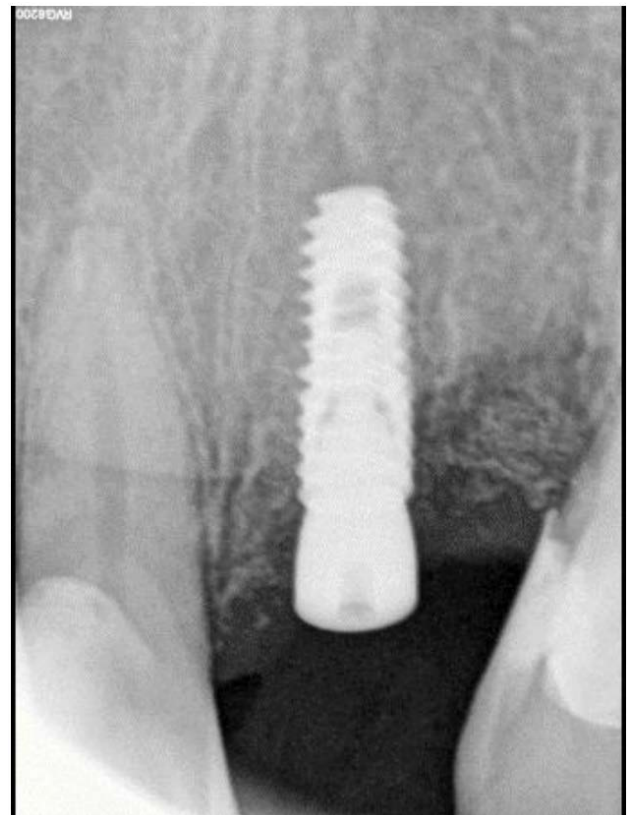
**Figure 4.** Post-surgical periapical radiograph.

The Osstem TSIII SA  $4.0 \times 10.0$  mm fixture was placed on #21 area (Figure 4). After completion of orthodontic treatment, 3 months of osseointegration period, temporary restoration was

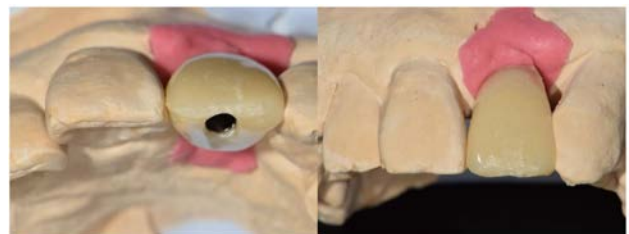
**Figure 5.** Fabrication of #21 implant temporary restoration.

fabricated and restored (Figure 5). The esthetic and function were evaluated for 3 months (Figure 6). With the consent of the patient, the final prosthesis of #21 implant was fabricated with a porcelain fused to metal crown. Considering the installed angle of the fixture, it was decided to make implant crown with UCLA type (Figure 7, 8). And finally, the prosthesis was delivered after minor adjustment of contour (Figure 9). Although the left and right sides were not perfectly symmetrical, the patient's smile line was low and the width of #11 and #21 implant prosthesis was similar. After the restoration of definitive prosthesis, the patient showed satisfaction with esthetics and function of implant prosthesis.

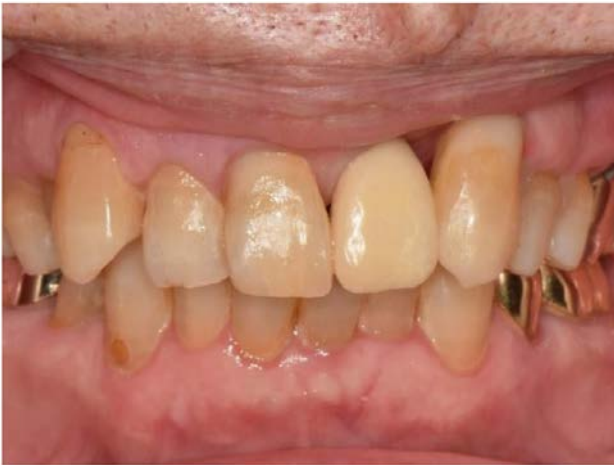
**Figure 6.** The implant temporary prosthesis delivery.

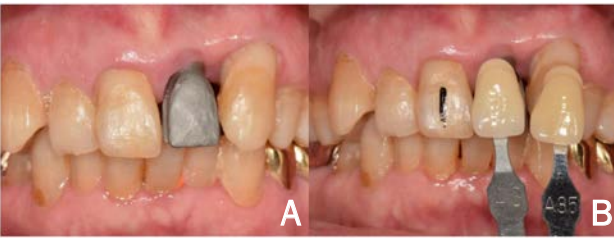
**Figure 7.** Photographs for metal frame and shade check. (A) Metal frame check for UCLA type prosthesis. (B) Shade check.

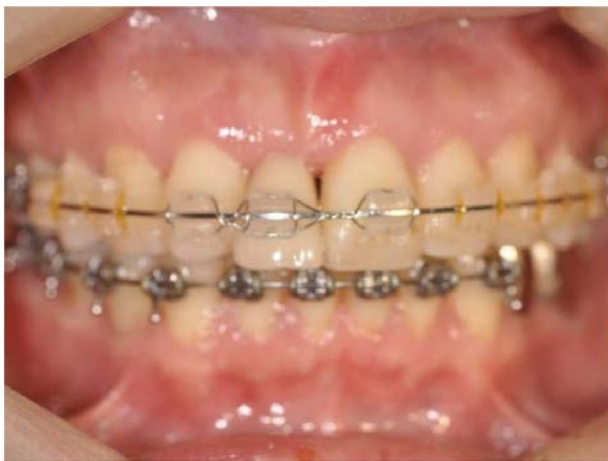
**Figure 11.** Temporary restoration of #11 with fixed orthodontic appliances.

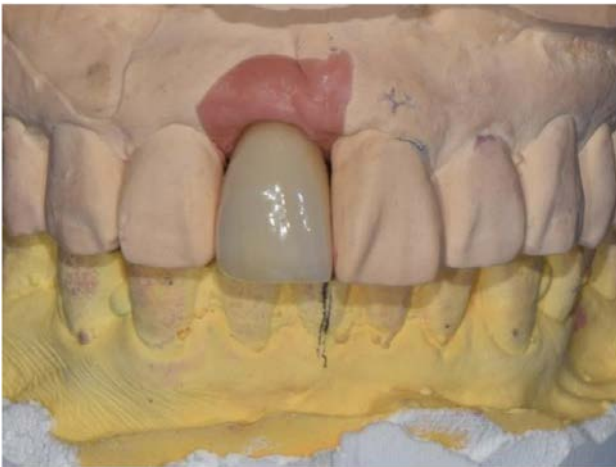
**Figure 15.** Definitive prosthesis of implant supported fixed prosthesis.

uated for 3 months. With the consent of the patient, the definitive prosthesis of the #11 implant made of porcelain fused to precious metal was restored (Figure 15, 16). In consideration of the angle of fixture and direction of loading, it was decided to make UCLA type prosthesis. And After definitive restoration, patient was satisfied with the results.
