# Dental implant failure repeated at the same site or occurred in one or more implants: A case report

Despite the fact that advances in science are improving the success rate of dental implants, a few implant failures consistently have been reported. Implant failure can come in three different forms; single, repetitive and cluster behavior. The single type refers to a single implant failure, the repetitive type refers to two or more failures at the same site, and the cluster type refers to more than one implant failure per patient that does not have to occur in the same position or quadrant. The purpose of this presentation is to investigate the rare cases of repetitive and cluster failure. (THE JOURNAL OF KOREAN ACADEMY OF OSSEOINTEGRATION 2022;14(1):36-43)

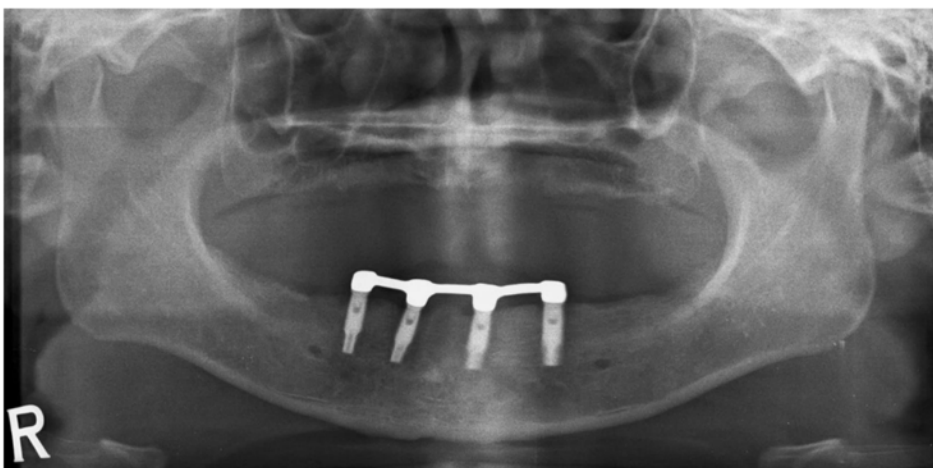
**Figure 8.** Pre-operative panoramic radiograph.

A 50-year-old male patient visited the clinic with a chief complaint of implant installation on maxilla. He had hyperlipidemia but didn't take any medication. He also had oligodontia history except #15, 25 tooth. As for the past dental history, #33, 35, 43, 45 implant was placed 15 years ago (USII 3.75 × 15 mm on #33,43 implant, and USII 4.0 × 15 mm on #35, 45 implant), and the maxilla was edentulous since two years ago due to extractions of #15 and #25. As for the treatment plan, after placing 4 implants in the maxilla, restoration was planned with implant-supported fixed-hybrid denture (Figure 8).

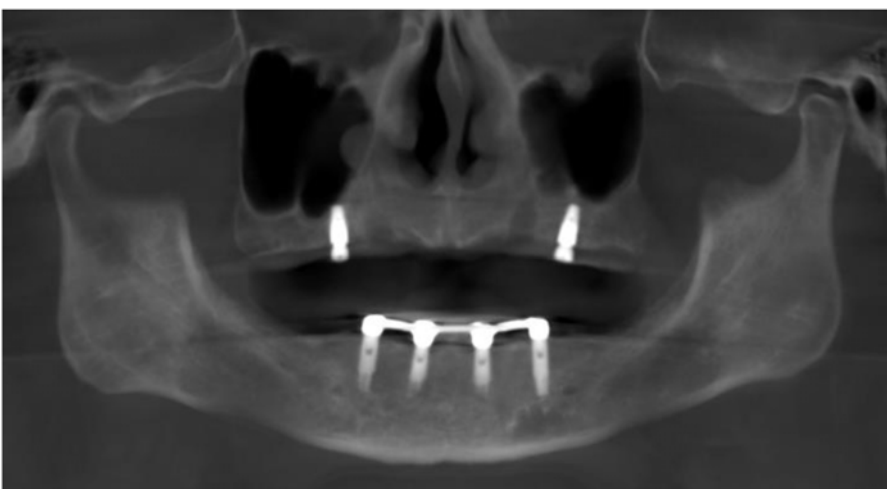
**Figure 15.** Panoramic view of CBCT image after #13, 23 implant removal.

After 1 month of #15 implant installation, he visited the clinic complaining of pain with a clicking sound at #23 implant site while chewing with provisional denture. Clinical examination revealed that ISQ value decreased to 55/61 without pain or screw rotation, so healing abutment was changed with a reduced height. 1 month after of that day, it was decided to remove the #23 implant with decreased ISQ value of 44/53, but #13 implant had a similar ISQ value of 60/61, so further follow-up was planned. When he visited the clinic for removal of #23 implant 1 month later, ISQ value of #13 implant decreased to 52/48, so #13 implant was removed at the same time as the #23 implant with atelocollagen sponge insertion (Teruplug®, Terumo biomaterials Co., Tokyo, Japan). No sign of osseointegration failure of #15,25

implant was seen at the follow up period, and prosthetic treatment was re-planned with overdenture instead of implant-supported fixed-hybrid denture (Figure 15).
